**2016 33' Grady-White Express Sport Yacht**  
**"Karvi"**

# **Report of Marine Survey**

Pre Purchase Survey #CMS2021-9-59

September 7, 2021

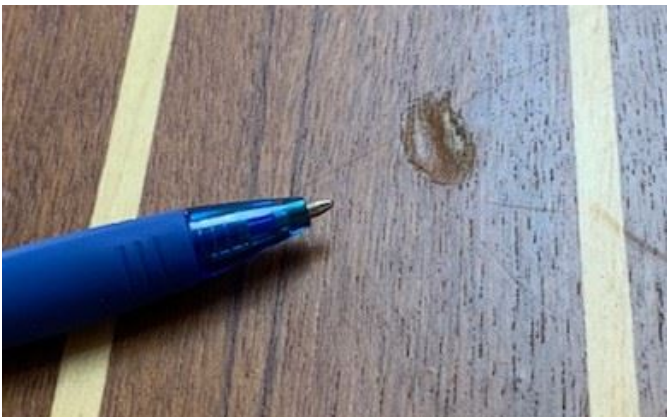
### FINDING C-1 FLOORING

Teak & Holly cabin sole. One small blemish was found. See finding.

Refinish or replace the flooring, as necessary.
