1998 63' Sunseeker Predator
"ZEUS"

Insurance Limited Condition & Valuation Survey

October 26, 2021

TYPE OF SURVEY REQUESTED: Condition & Value Finance/Insurance
DATE OF SURVEY INSPECTION: October 26, 2021
FILE NUMBER: #CMS2021-10-69
VESSEL TYPE: Hardtop Yacht
VESSEL BUILDER: Sunseeker International Limited
HIN (HULL IDENTIFICATION NUMBER): XSK00968C898
MODEL YEAR: 1998
YEAR BUILT: 1998 (per Hull Identification Number)
DOCUMENTED HAILING PORT: Seattle, WA
U.S.C.G. DOCUMENTATION NUMBER: 1197136 (current)
STATE REGISTRATION NUMBER: (Affixed decal was missing).
STATE REGISTRATION DECAL NUMBER: (Affixed decal was missing).
VESSEL MATERIAL: Fiberglass
LENGTH OVERALL (LOA): 65'7", as reported by BUC VALUE PRO
REGISTERED LENGTH: 63'
LENGTH ON DECK (LOD): 59'7", as reported by BUC VALUE PRO
BEAM: 15'7" , as reports by BUC VALUE PRO
DRAFT: Measured approximately 4'6" at props.
DISPLACEMENT: Weighed approximately 62,391 lbs. on the travel-lift scales.
DEPTH: 4'1"
LOCATION OF SURVEY INSPECTION: Shilshole Marina, Seattle, WA

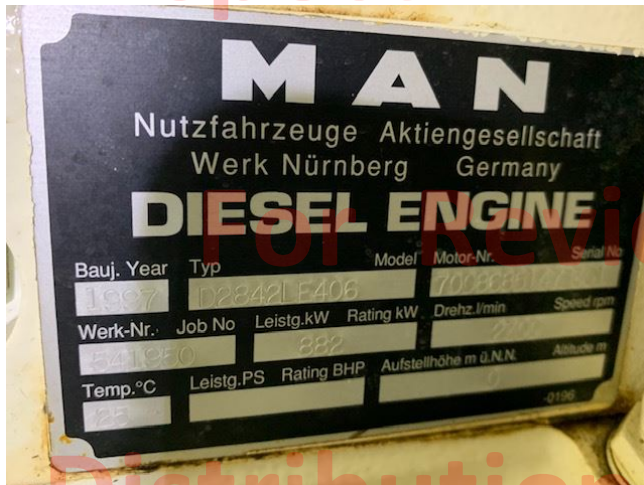
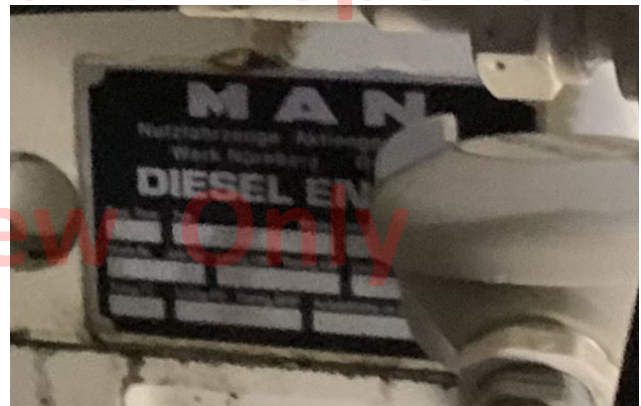
ENGINE LABELS & NOTICES

Limited access only allowed for partial photos of tags. See below.

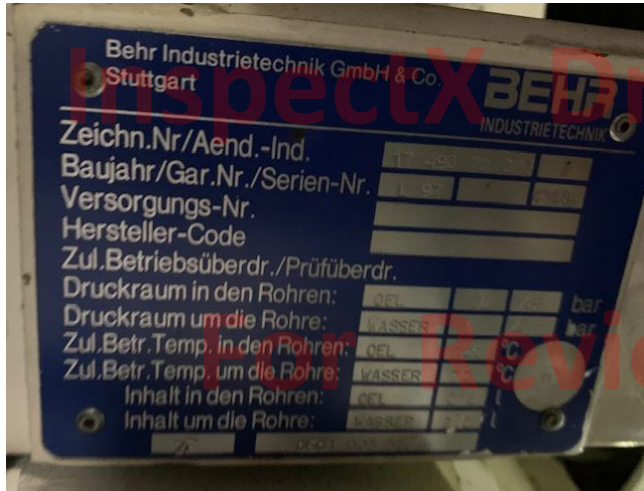
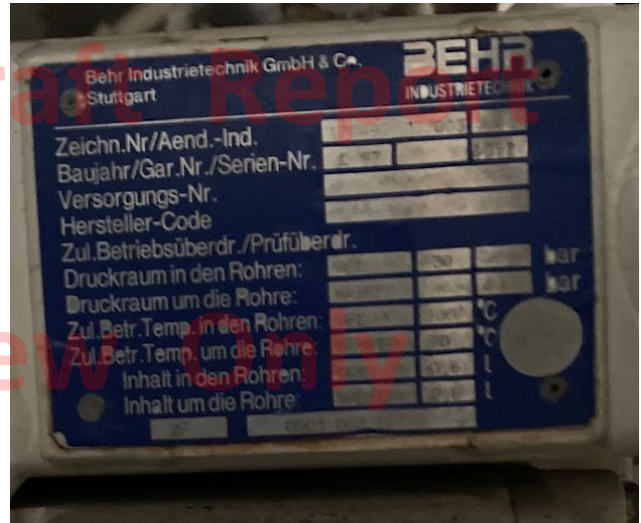
Unknown (data tags were illegible). See tags below.

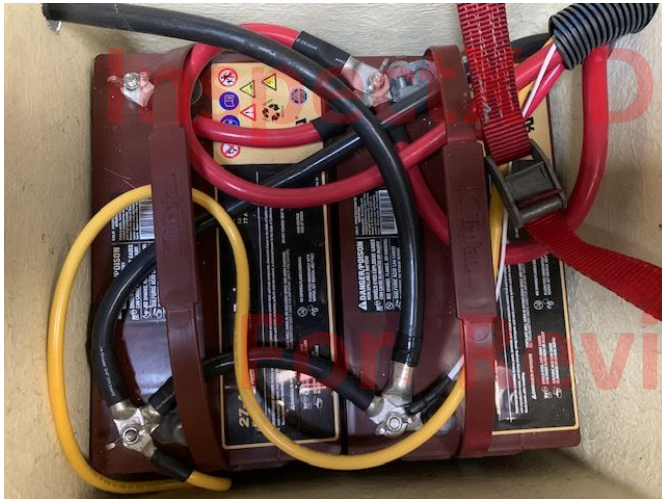
Wing nuts were utilized to connect the generator & bow thruster battery's cable conductors to their terminals (not recommended for cables over 6 AWG or 13.3 mm diameter).

Install properly sized hex nuts to secure battery cable conductors to their terminals (on battery cables over 6 AWG of 13.3 mm in diameter) to comply with ABYC Standards.

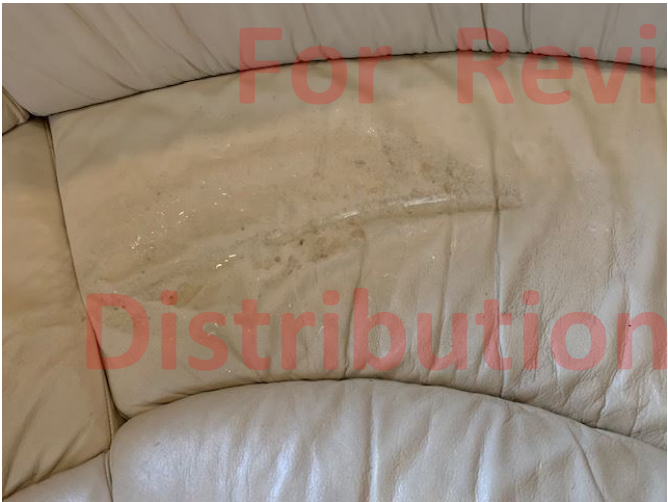
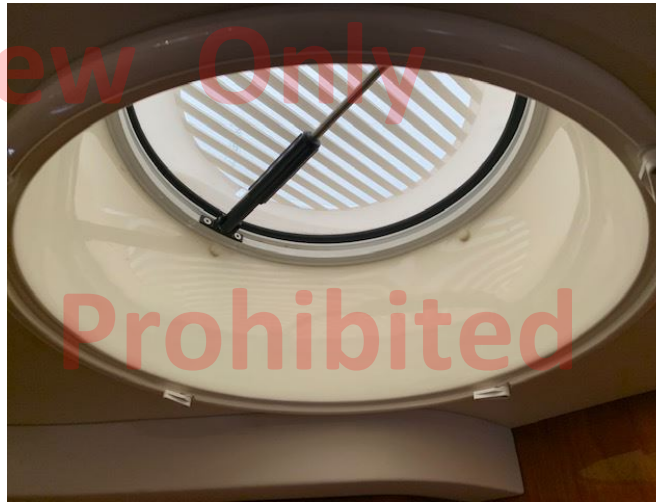
Three opening deck hatches on foredecks. Exceptions sighted. See finding.

Two of the forward deck hatch-seals were leaking into the cabin. One was located in the main salon above the settee, port. The other was directly over the main stateroom. Appeared to be faulty rubber seals.

Investigate further, and repair or replace the hatches as necessary.

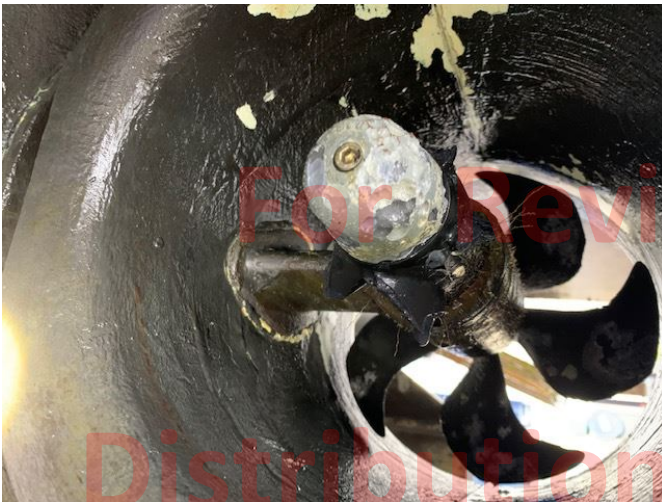
FINDING B-2 THRUSTERS

Five bladed bow and stern thruster propellers. Stern thruster port propeller was broken completely off. Owner order replacements for both stern props at time of survey. See finding.

One of the stern thruster's propeller blades were broken off.

Investigate further, and service, repair or replace as necessary.
