**2015 51' Sea Ray 510 "FLY"**  
**"Wawai"**

# Report of Marine Survey

Pre Purchase Survey #CMS2021-5-25

2015 51' Sea Ray 510 "FLY"

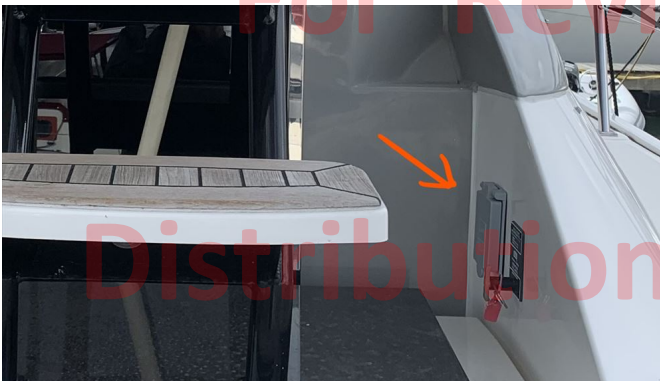
The GFCI electrical outlets located in the starboard cockpit location had no power and failed to trip with a UL Listed Circuit Tester and by their test buttons.

Investigate further/trace, and install GFCI protected outlets as necessary. ABYC E-13.3.5, If installed in a head, galley, machinery space or on a weather deck, receptacles shall be protected by a Type A (nominal 5 milliamperes) Ground Fault Circuit Interrupter (GFCI).

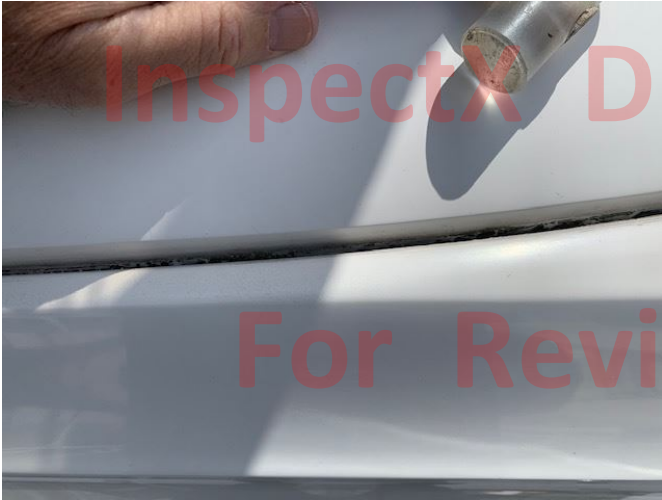
### **FINDING B-1** GENERAL CAULKING/SEALANT CONDITION

General weathering has developed on some of the vessel's exterior caulking sealants, including the window seals. Exception noted. See finding.

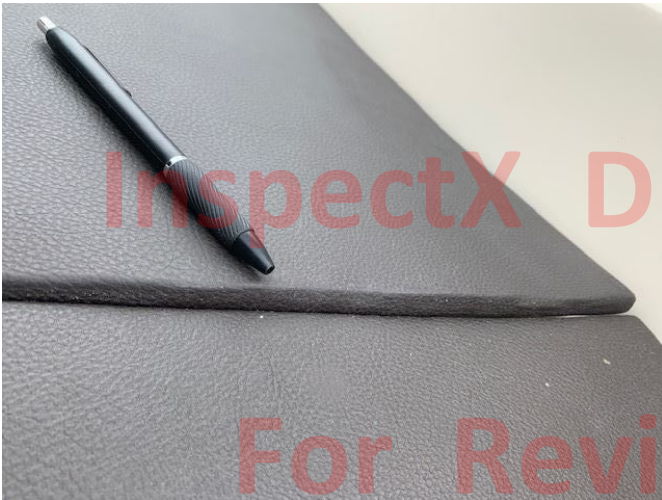
### FINDING B-2 CEILING HEADLINERS

Headliner material is vinyl. The foredeck of the salon is a dark brown vinyl just beneath the main windshield (above companion way). It has a 1/4 foam backing. Exceptions sighted. See finding.

The interior vinyl foredeck covering around the upper companion way was buckling/sagging in some areas (appeared to have failed foam adhesives caused by sun exposure and or water intrusion).

Refinish or replace the coverings, as necessary. Investigate any water intrusion prior to refinishing.

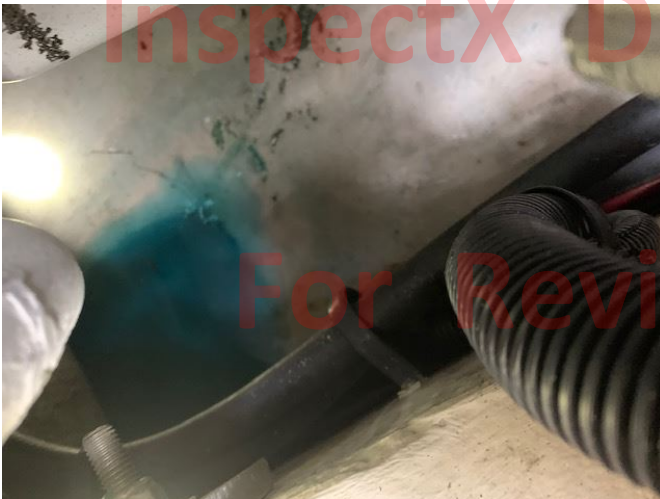
### FINDING C-1 BILGES

A gelcoated surface was used in the bilges. Some "blue" antifreeze was found collected in the engine room, starboard bilge. See finding.

Slight antifreeze was observed collecting in the bilges.

Investigate further, trace all sources and address as necessary.
