**2015 51' Sea Ray 510 "FLY"**  
**"Wawai"**

# Report of Marine Survey

Pre Purchase Survey #CMS2021-5-25

2015 51' Sea Ray 510 "FLY"

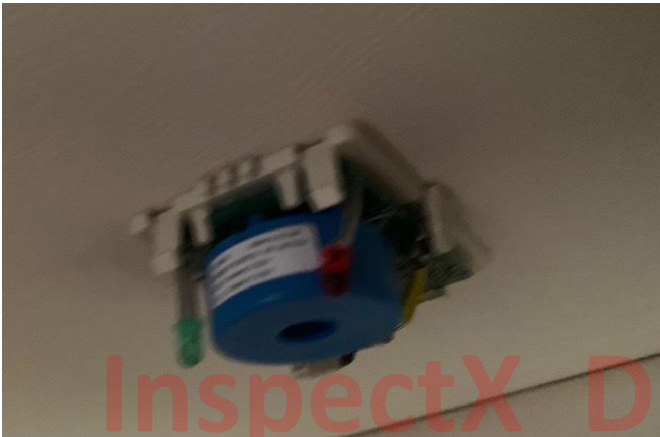
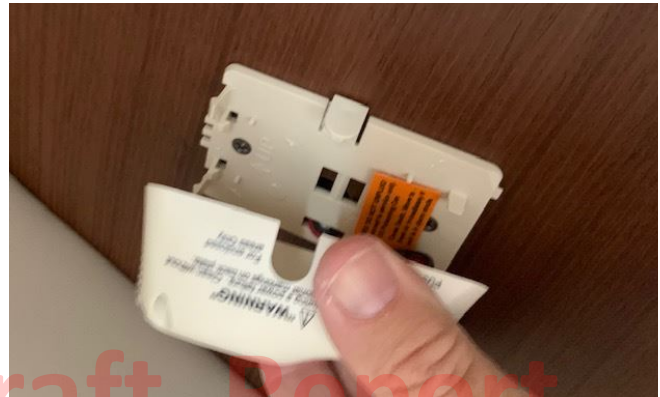
(ABYC A-24.7) A carbon monoxide detection system shall be installed on all boats with enclosed accommodation compartment(s). Carbon monoxide is a toxic, odorless, colorless, tasteless gas produced by the burning of carbon-based fuels. Carbon monoxide in high concentrations can be fatal in a matter of minutes. Unless the symptoms are severe, carbon monoxide poisoning is often misdiagnosed as seasickness; however, lower concentrations must not be ignored because the effects of exposure to carbon monoxide are cumulative and can be just as lethal.
